FACILITY CONDITIONS ASSESSMENT

CITY OF
BIWABIK
MINNESOTA

CITY HALL, PAVILION, AND PUBLIC WORKS
March 3, 2025
BIWAB 182118

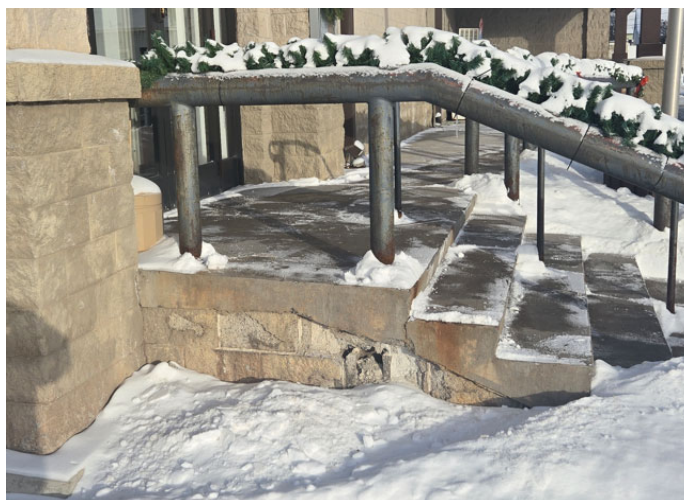
Deterioration at entry steps and guardrail.

Masonry/concrete repairs are recommended at the exposed vertical edge of the entry stairs to prevent further deterioration. It is also that the large diameter steel guardrails along the entry stairs be refinished to remove corrosion and protect the railings integrity.

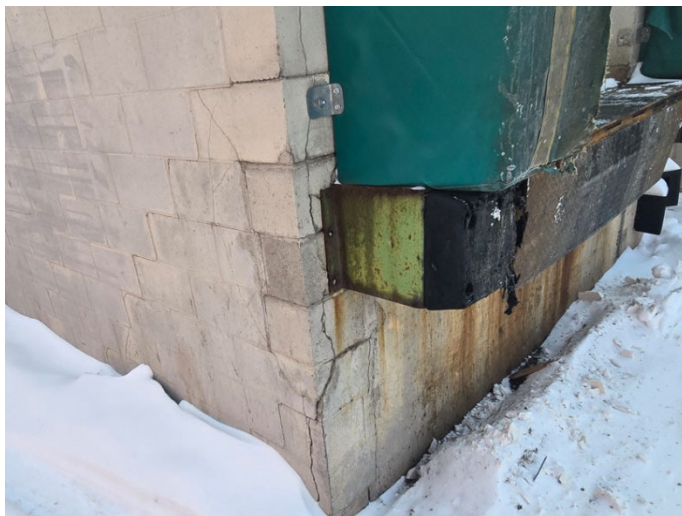
Along the north side of the building near downspout locations, moisture has degraded the face of the wall, removing paint in areas. Would recommend a full clean, tucking pointing any eroded joints, and adding kick-out deflectors to the downspouts to keep moisture off the face of the wall. Similar repair work is recommended at the loading dock area, where CMU showing signs of wear and some cracking.

Deterioration at loading dock leveler.

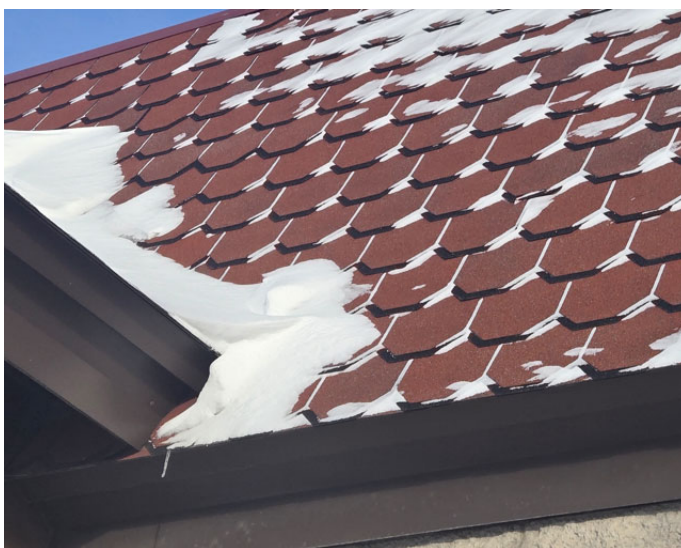
Photo of asphalt shingles.

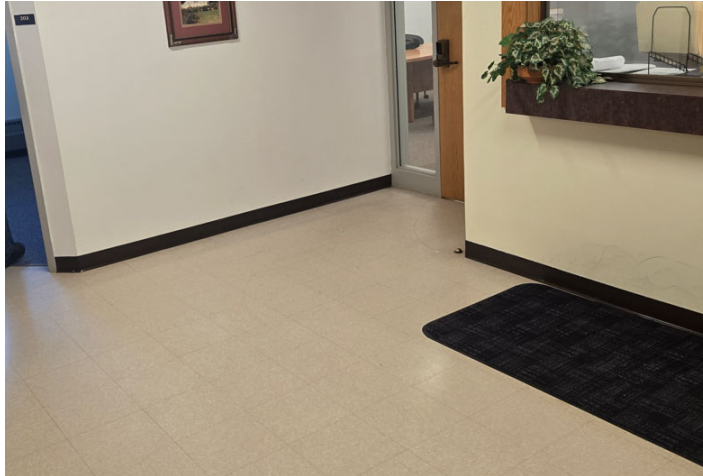
As a result of a water line break in 2008, a majority interior finishes were replaced or updated and have not been altered since. Interior finishes throughout are in fair condition and will function as originally intended for several more years but the overall appearance is generally dated and would benefit from a refresh.

Photo showing typical Lobby finishes.

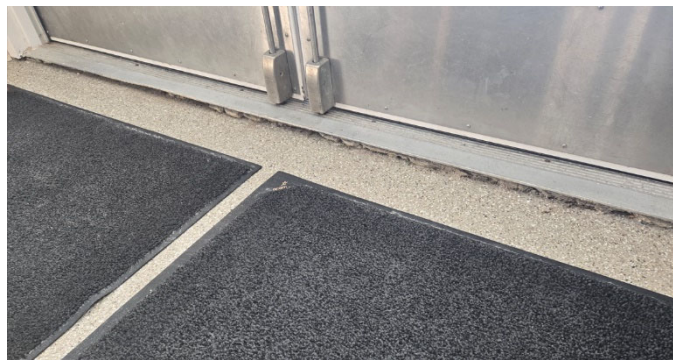
At the east entry door, it was noted that there appears to be minor heaving of the exterior stoop or settlement of the interior slab creating a minor trip hazard. It is recommended that the door sill be removed, concrete ground down and sill reinstalled to reduce the possible trip hazard.

Photo showing raised sill/trip hazard at east entrance.

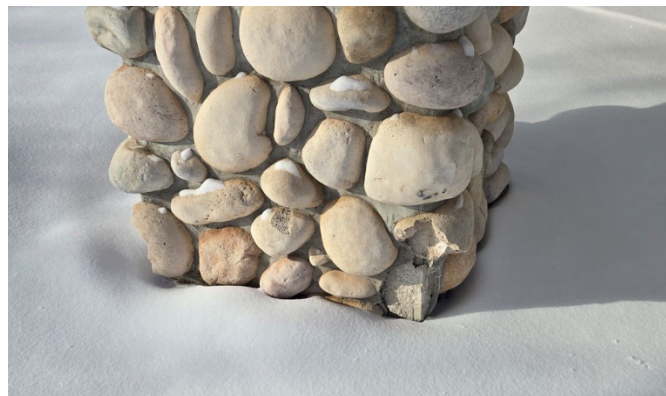
damage likely due to impact from lawn care or snow removal equipment and from the use of salt on adjacent sidewalks in the winter months. The vinyl siding appears to be in good condition, but the wood trim has significant peeling paint and is in need of refinishing to prevent rot and decay.

Photo showing stone veneer damage.

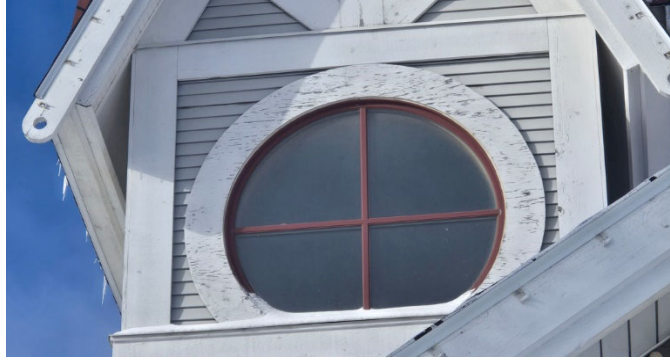
Photo showing signs of paint flake and weathering.

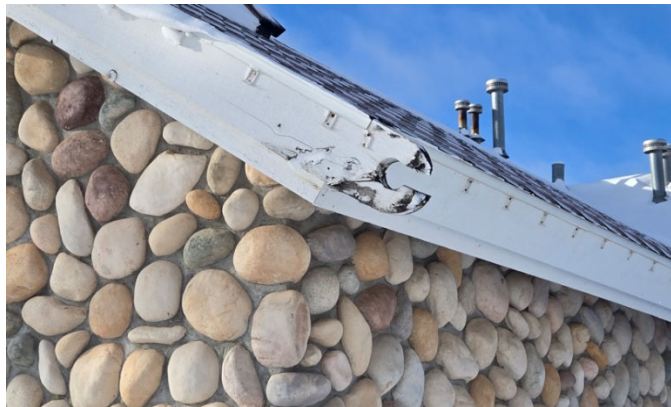
Photo showing wood decay at decorative element.

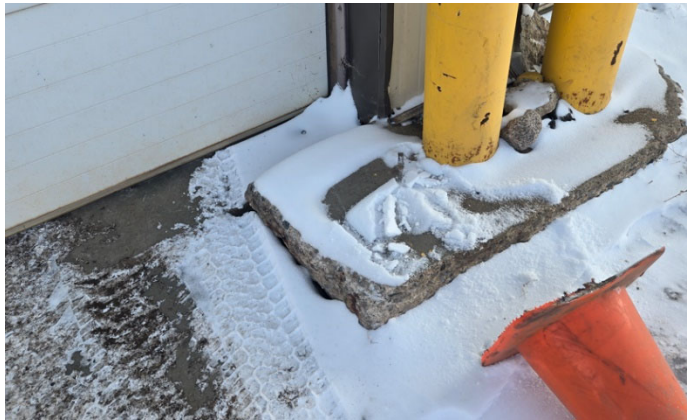
Photo showing one of the raised bollard piers infringing on overhead door entry.

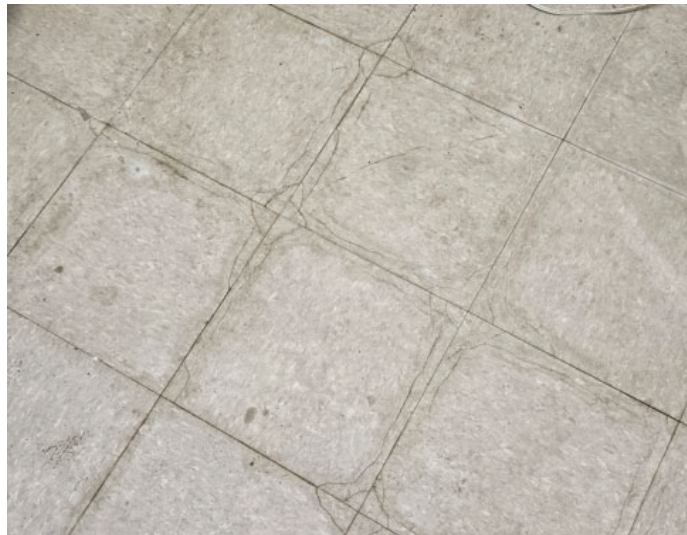
Photo showing typical condition of VCT flooring within office area.

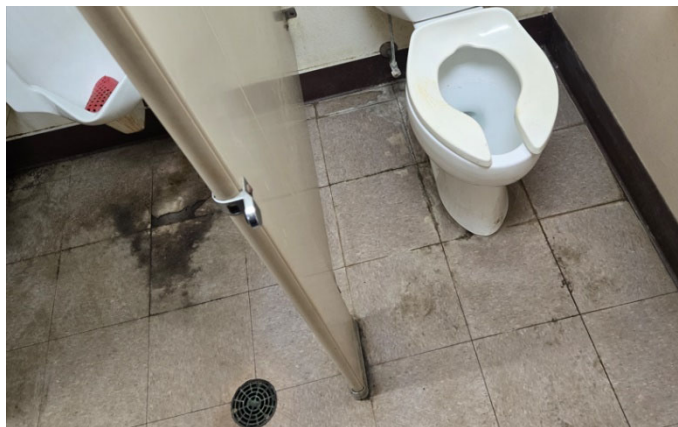
Photo showing condition within restroom around plumbing fixtures.

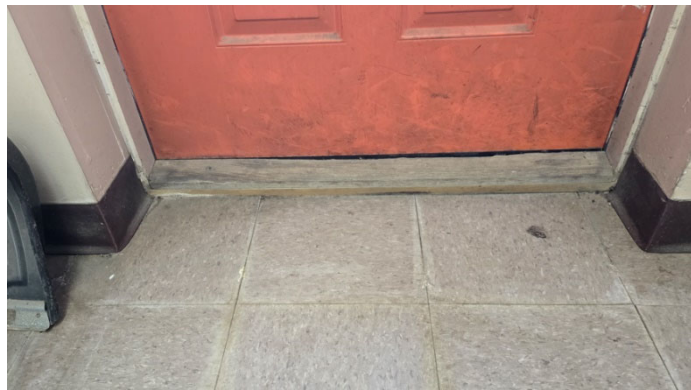
Photo showing raised sill/threshold at north entrance door.

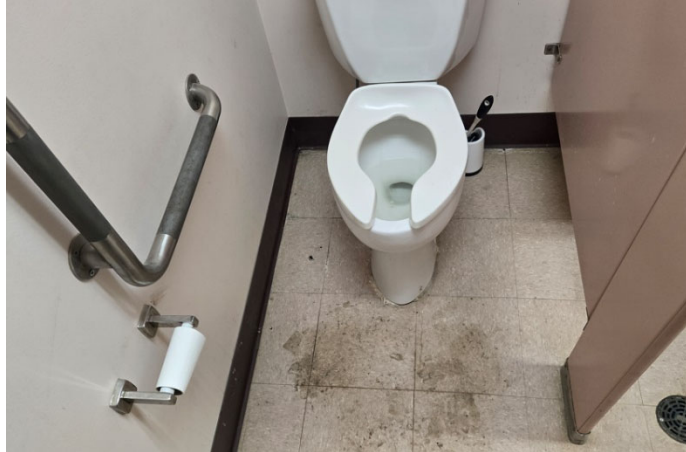
The current men's and women's restrooms do not provide compliant toilet stalls, fixture mounting heights or clear floor space minimums to meet current accessibility standards and codes. Restrooms should be renovated to either create larger multi-user facilities or they could be converted into single-user restrooms without toilet stalls and partitions. Restrooms do display proper signage with braille as required by the Americans with Disabilities Act (ADA).

Photo showing typical restroom stall configuration.
